REPORT ON LEVEE FAILURES AND DISTRESS
SAN JACINTO RIVER LEVEE AND BAUTISTA CREEK CHANNEL,
RIVERSIDE COUNTY, SANTA ANA RIVER BASIN, CALIFORNIA

August 1980

Prepared for
U. S. Army Engineer District, Los Angeles
Los Angeles, California

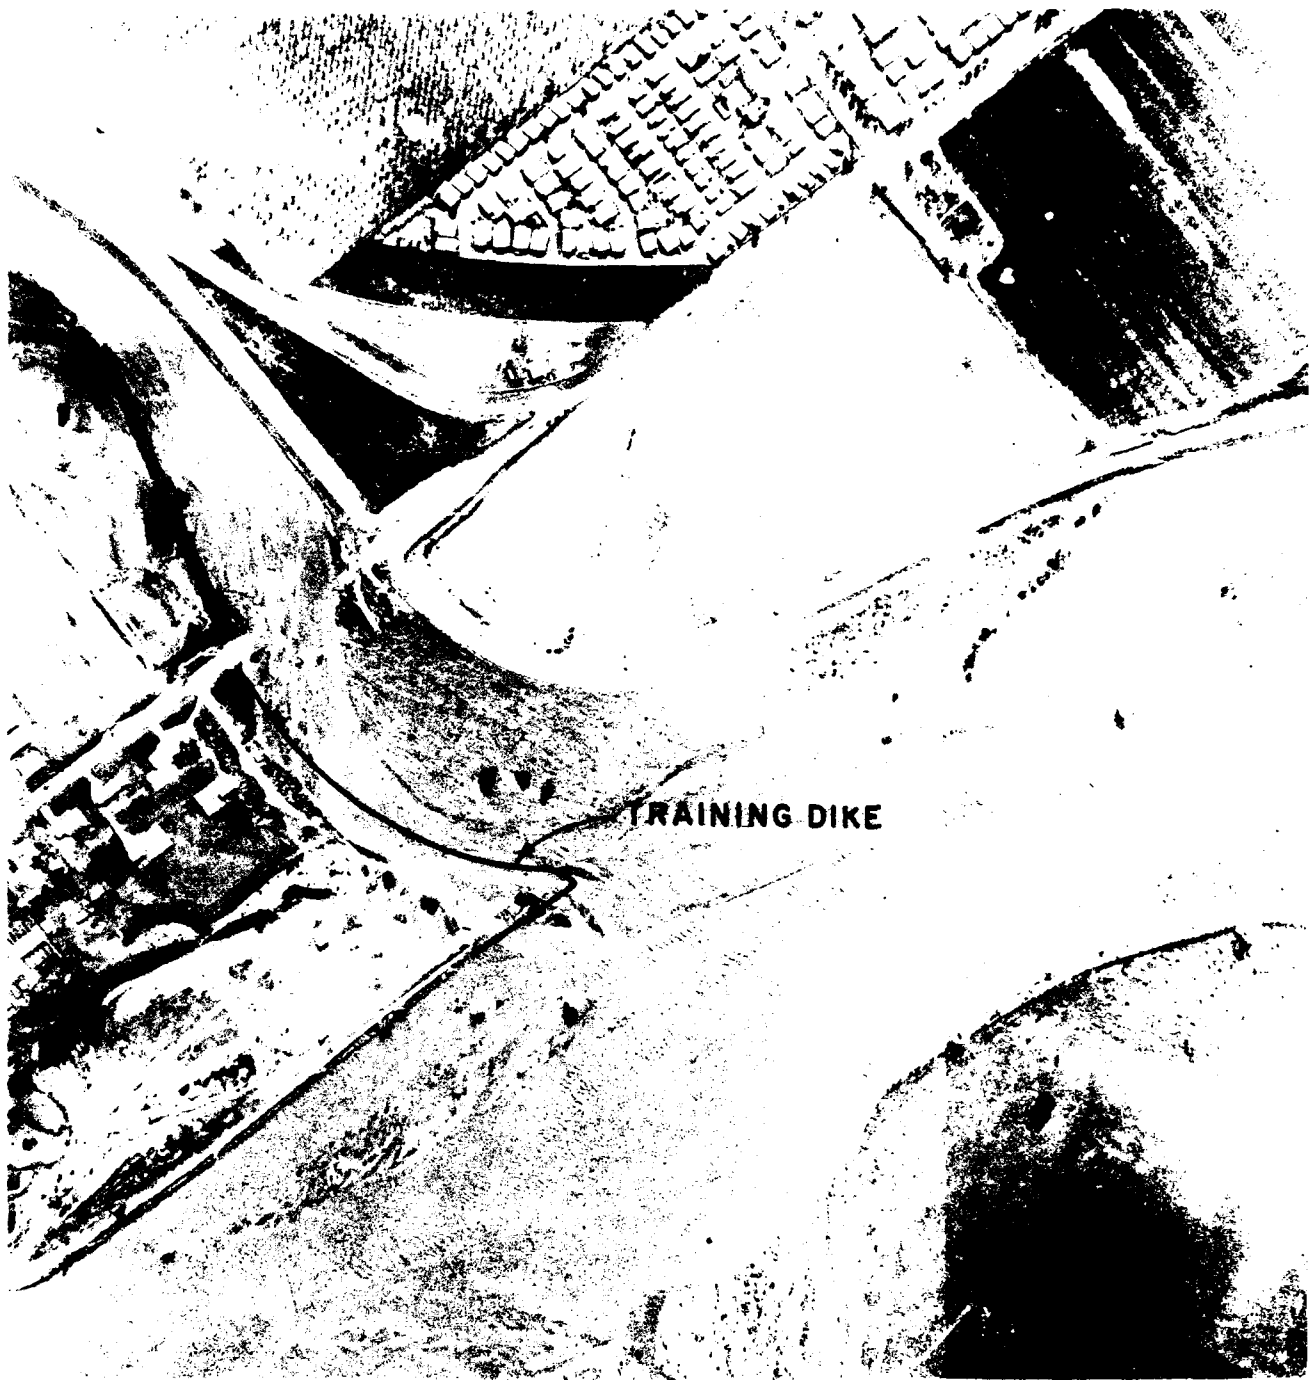
BAUTISTA CREEK
TRAINING DIKE

The combined effects of the vertical well-field wall, located at right angles to San Jacinto River upstream of the confluence, and the abrupt junction of Bautista Creek with San Jacinto River cause flows to be deflected to the upstream end of the right Indian levee, then across the San Jacinto River channel to the left CE levee, back across the channel to the upstream end of the RCFC and WCD levee, back to the CE levee just below the Main Street crossing, and generally parallel to the CE levee downstream of sta 60+00. The recent survey, showing streambed topography, clearly indicates this meandering path of flow and areas of flow impingement on the levees (Plates 10 through 13).

The additional construction should include measures that will reduce flow meandering and thereby decrease scour in impingement areas. Flow meandering would be reduced by the construction of a training dike (Plate 10) from the riverward end of the vertical well-field wall upstream, approximately parallel to the right bank of San Jacinto River for a distance of nearly 2000 ft to the left bank of the river. The training dike could be constructed of large stone, which would be overtopped by flood exceeding a frequency of once in 25 to 50 years. Flow meandering would also be reduced by the alternative

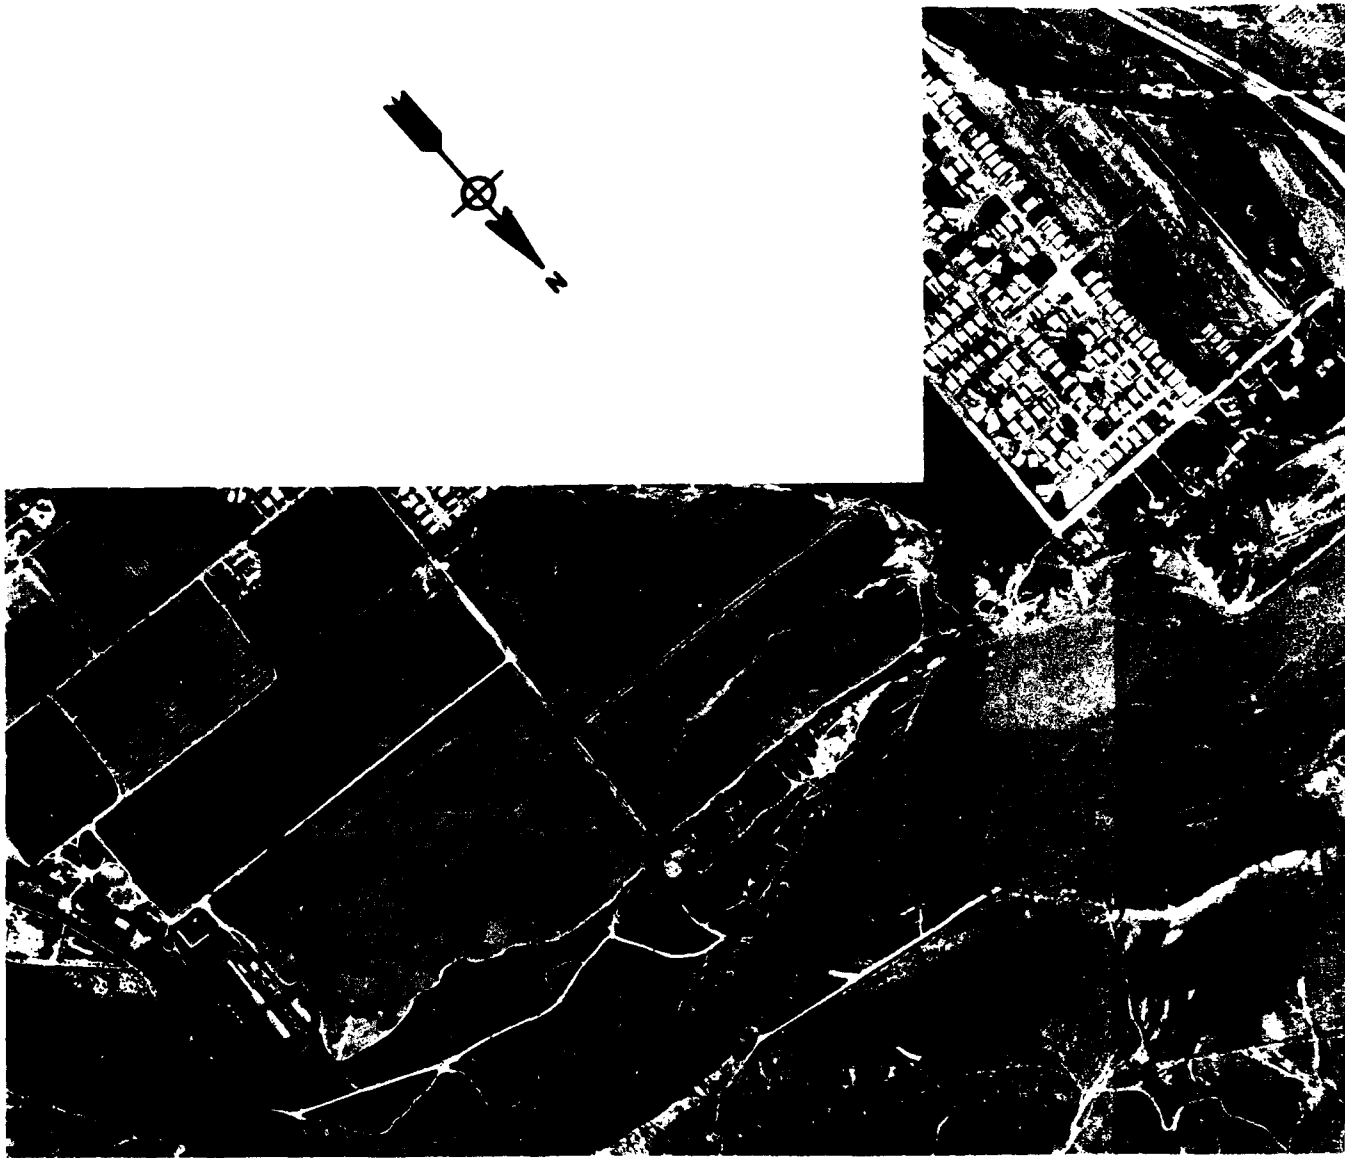
PLATE 1 3

During February 1980, flooding caused the San Jacinto River flood control project to undergo distress. Levees on both San Jacinto River and Bautista Creek reaches were, in fact, breached, as evidenced in the aerial mosaics presented in Plates 1 and 2. Because of this occurrence and at the request of the U. S. Army Engineer District, Los Angeles, an Engineer Team was formed and tasked with determining the probable cause or causes of failure, recommending remedial construction measures, and making recommendations as to the application of this experience to existing and future projects. Team members (specialists in hydraulic, geotechnical, and construction engineering) are:

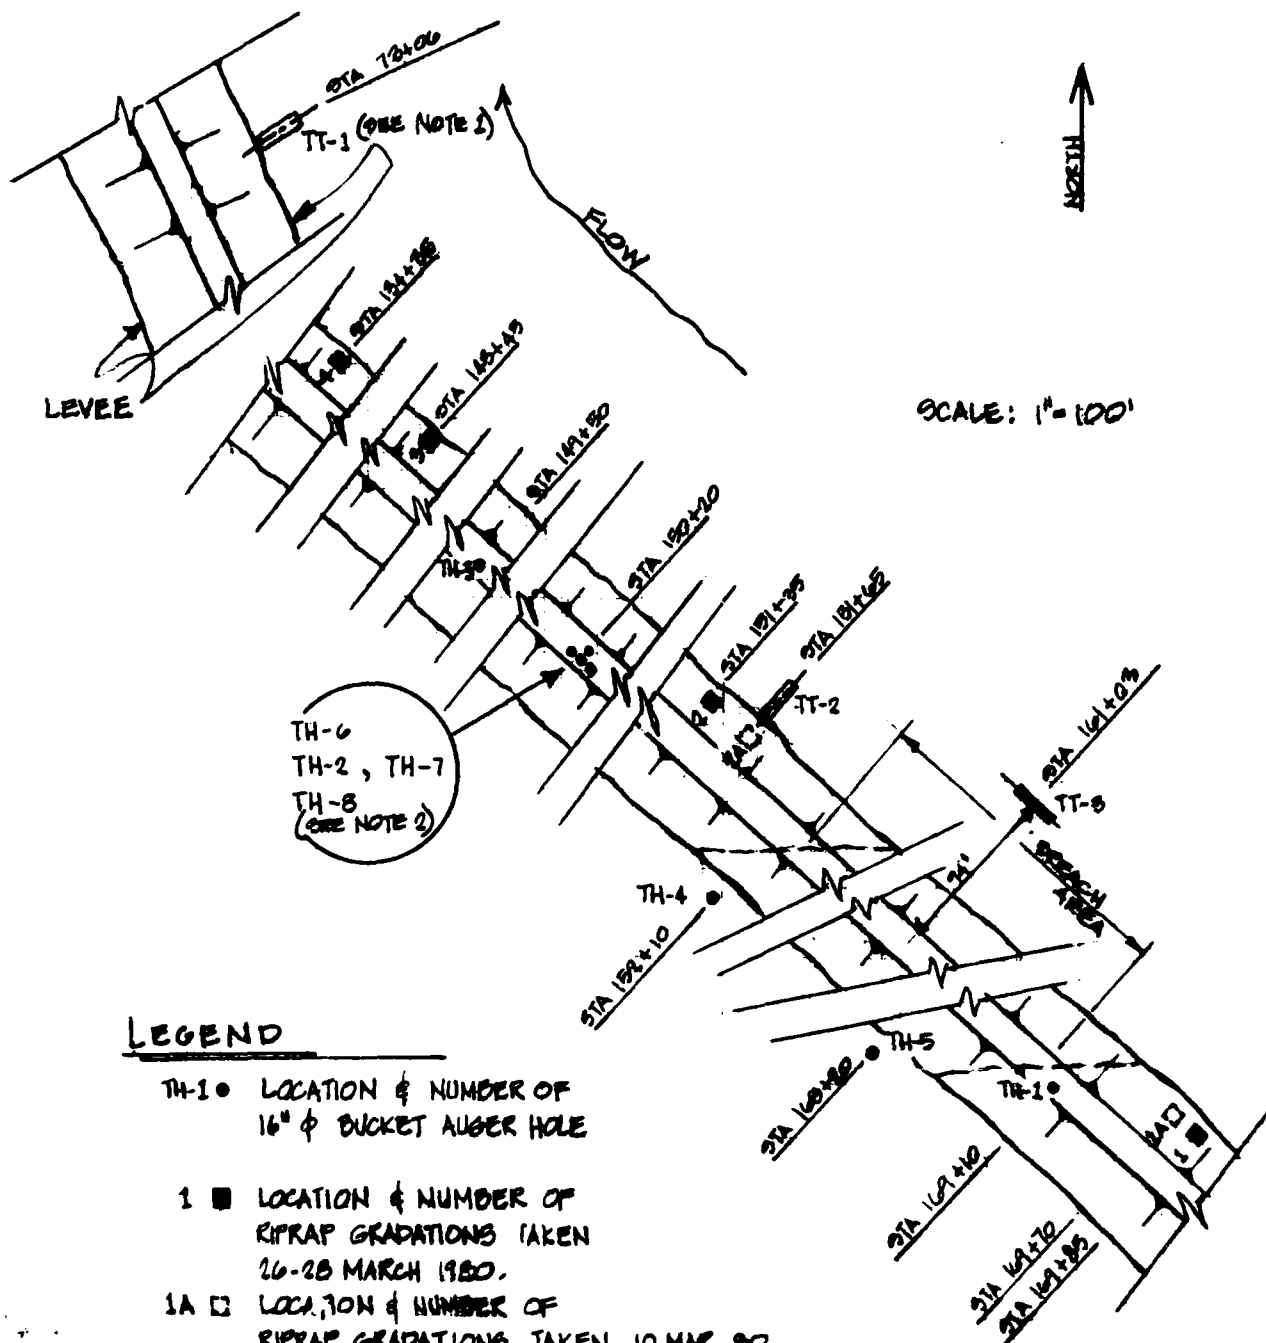
LOCATION OF FIELD INVESTIGATIONS

1. TEST TRENCH 1 IS LOCATED 1470 FEET
DOWNSTREAM OF MAIN ST. CROSSING
OR JUST D.S. OF LEVEE SLOPE FAILURE.
2. TEST HOLES 6, 7, & 8 ARE 5 FEET FROM
TEST HOLE 2.

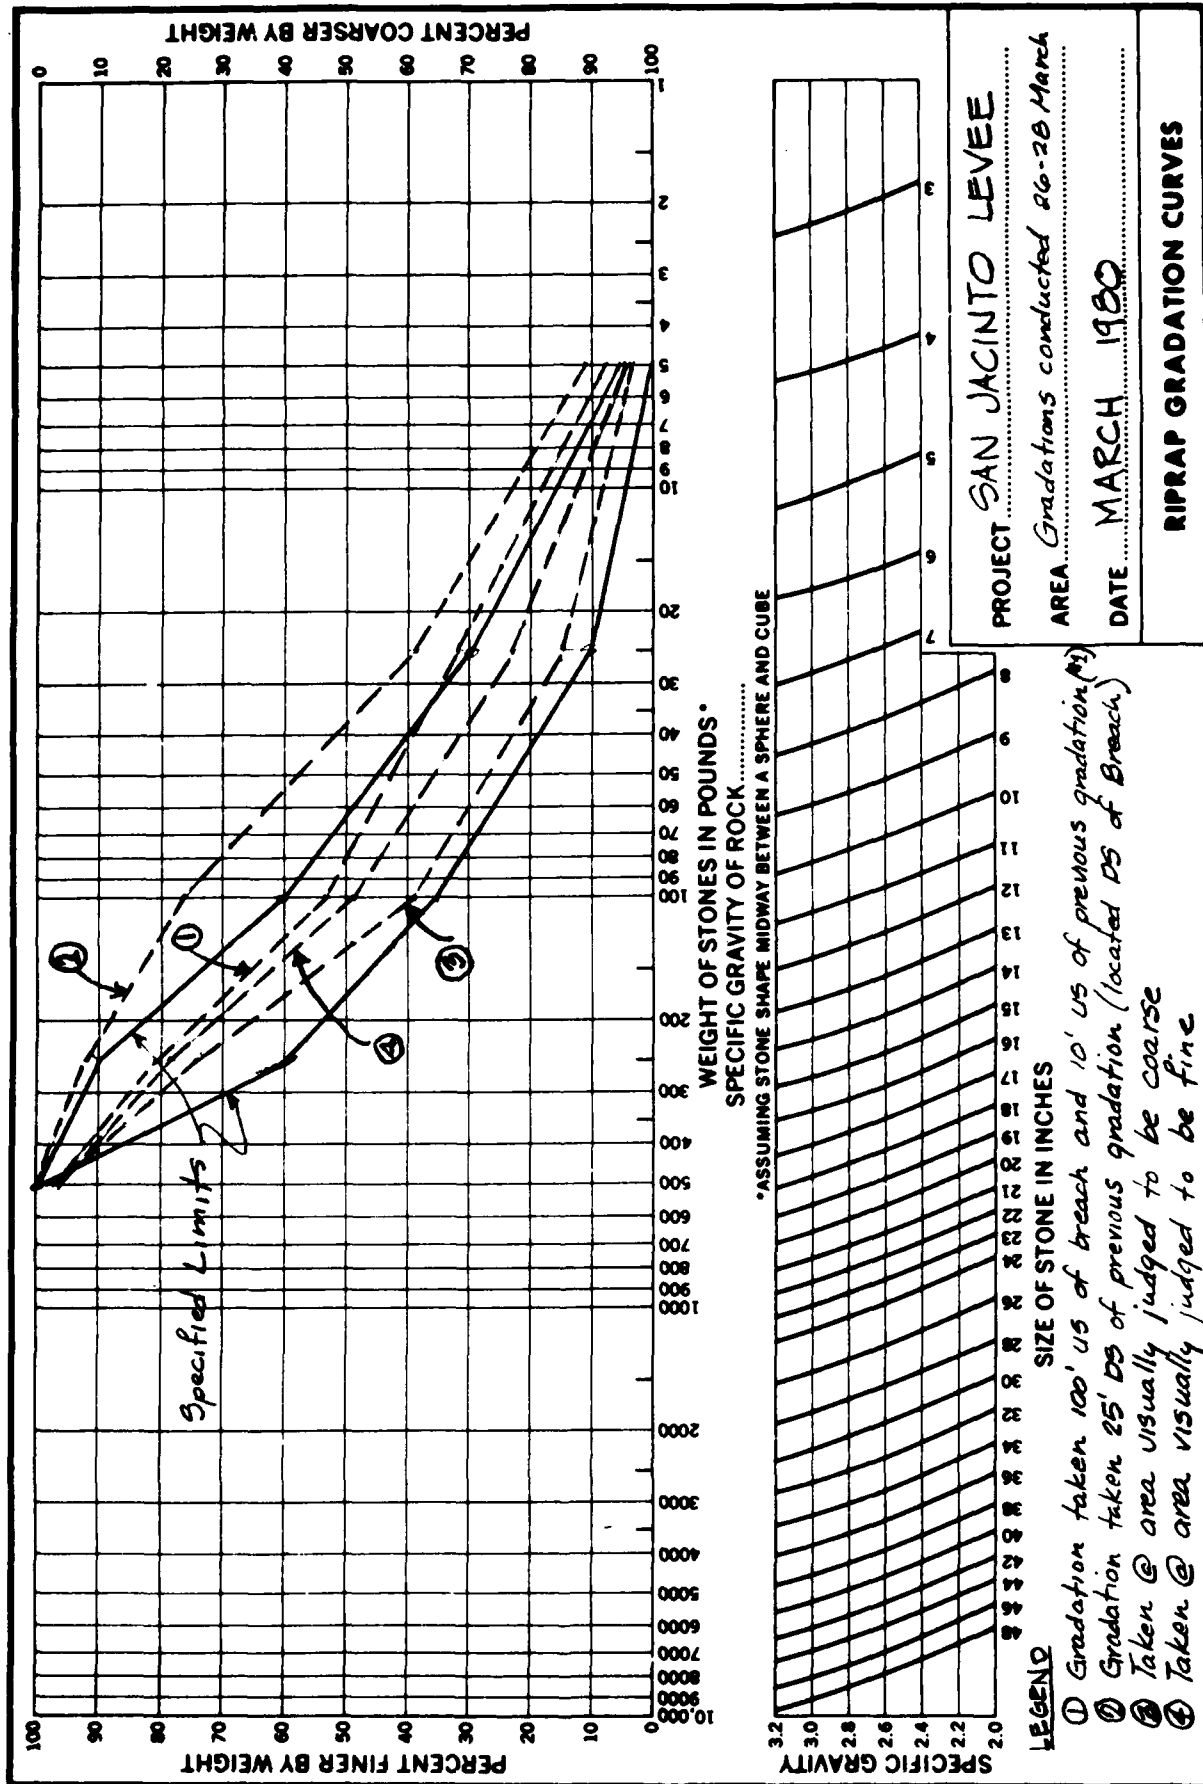
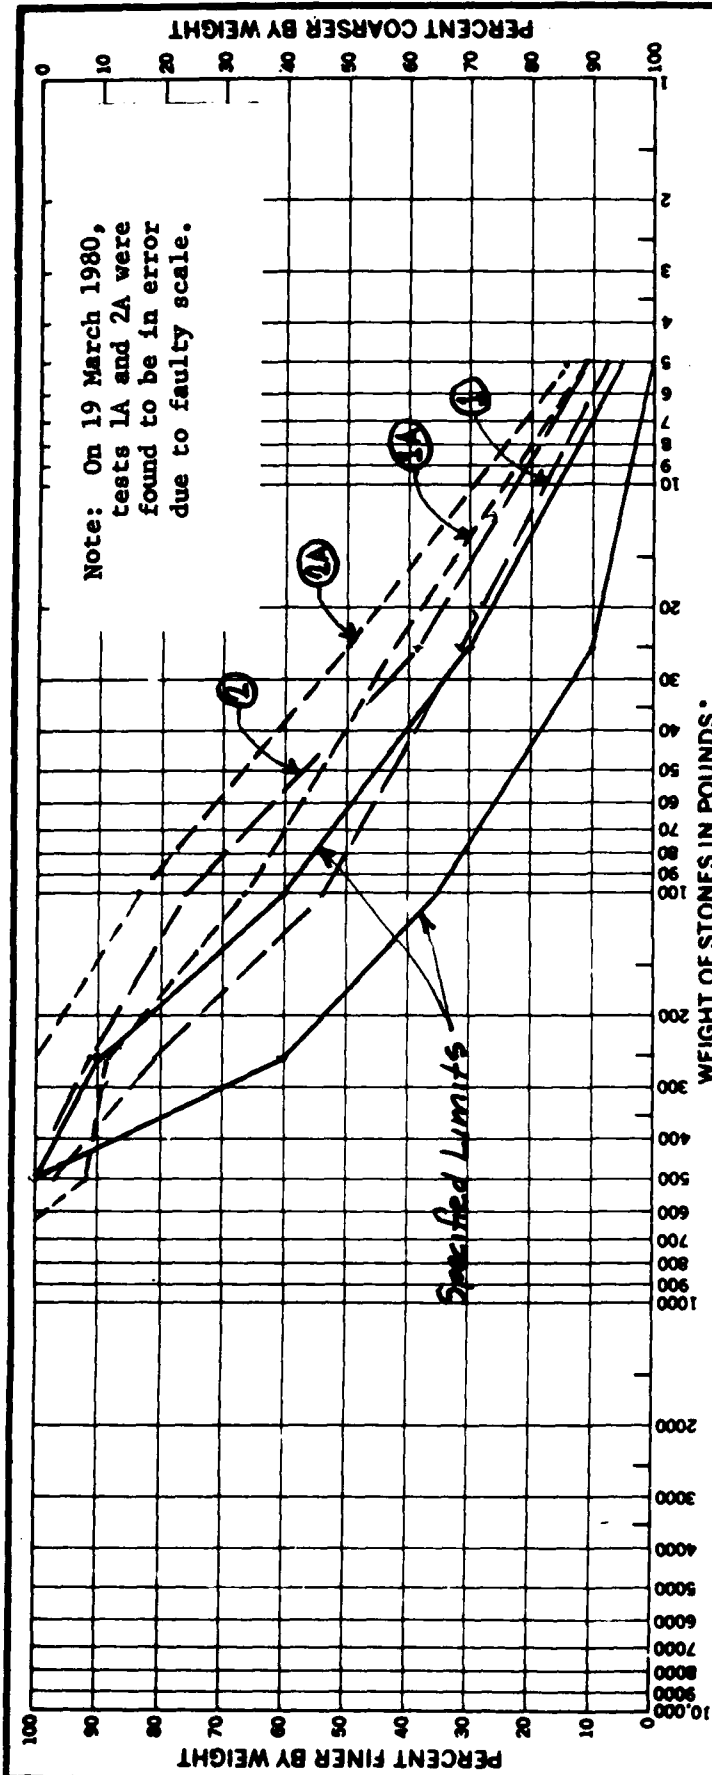
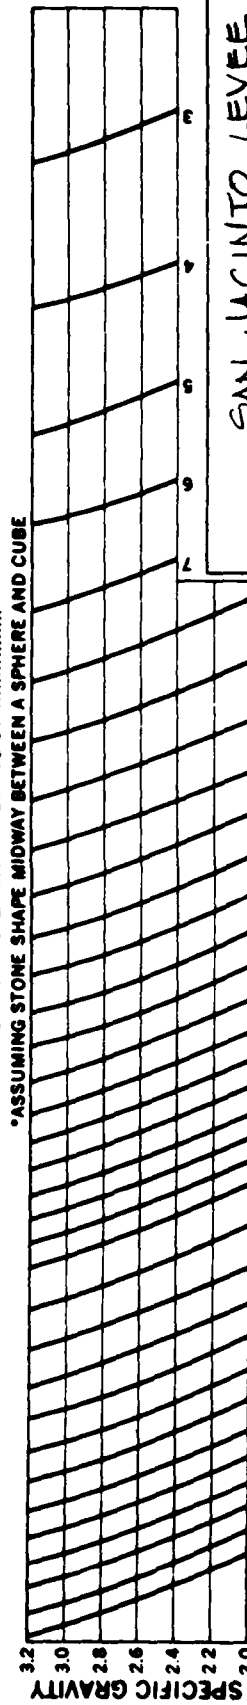
<u>Test #1</u>	<u>Test #2</u>	<u>Test #3</u>	<u>Test #4</u>	<u>Specified</u>
% Wt - 500 lb.	97	100	97	96	100
% Wt - 250 lb.	80	92	74	79	60-90
% Wt - 100 lb.	53	77	39	49	35-60
% Wt - 25 lb.	32	39	15	23	10-30
% Wt - 5 lb.	8	11	4	5	0-5
Area of Test	100 SF	85.5 SF	100 SF	80 SF	-
Total Yield (lbs)	17,462	13,327	16,134	13,250	-
Average Thickness	1.5'	1.5'	1.5'	1.5'	1.5'

- LEGEND**
- ①A Original gradation (10 March) upstream of breach.
 - ① Gradation (26 March) located 10' US of ①A
 - ②A Original gradation (10 March) downstream of breach.
 - ② Gradation (27 March) located 25' DS of ②A
